Baxter State Park

Trail Maintenance Inventory & Planning

BSP Advisory Meeting

April 10, 2012

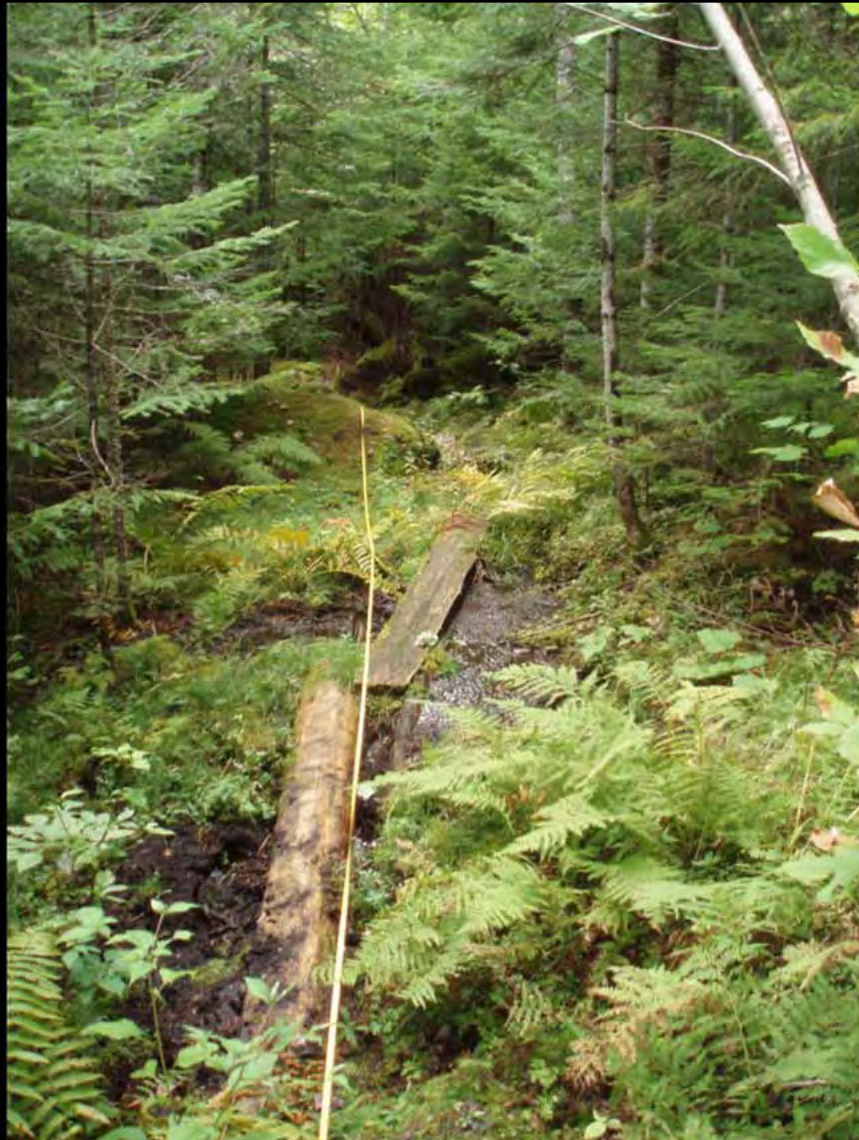
Rum Pond Trail

So these trails require maintenance. Because they may look like this....

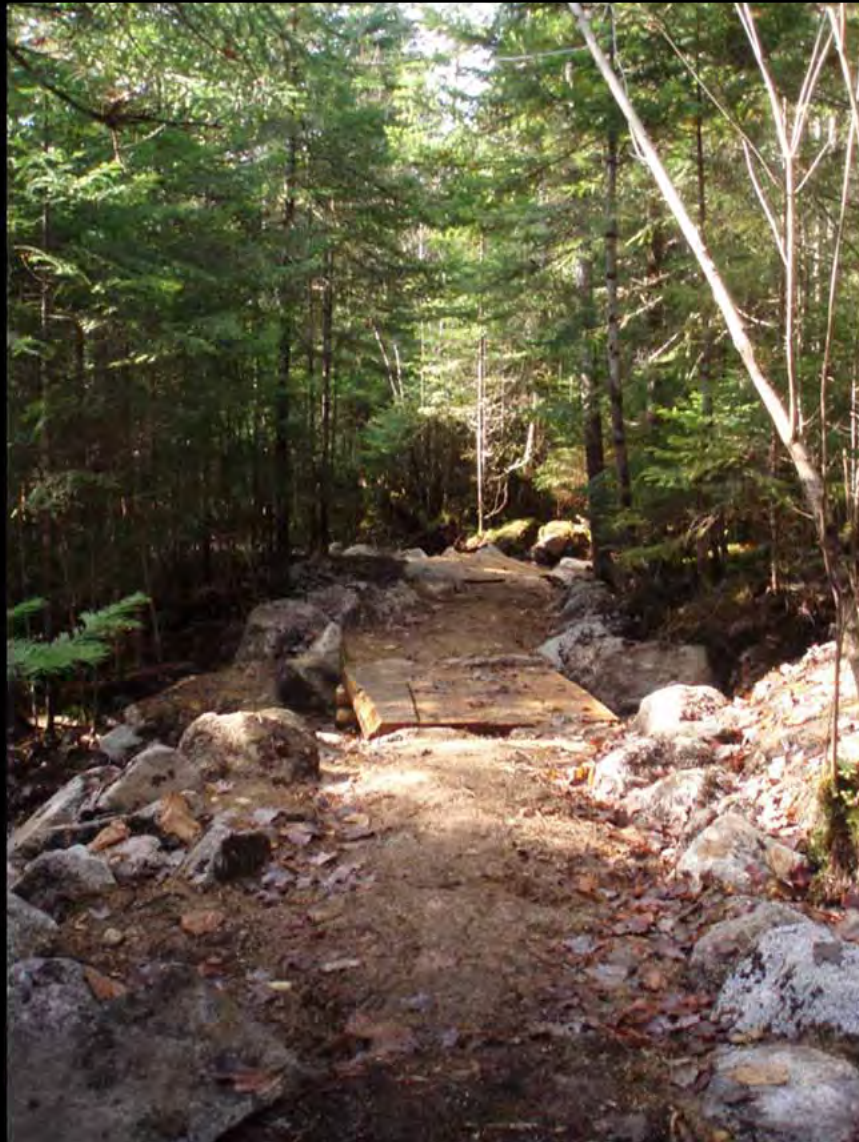
Rum Pond Trail

...And we may want them to look like this.

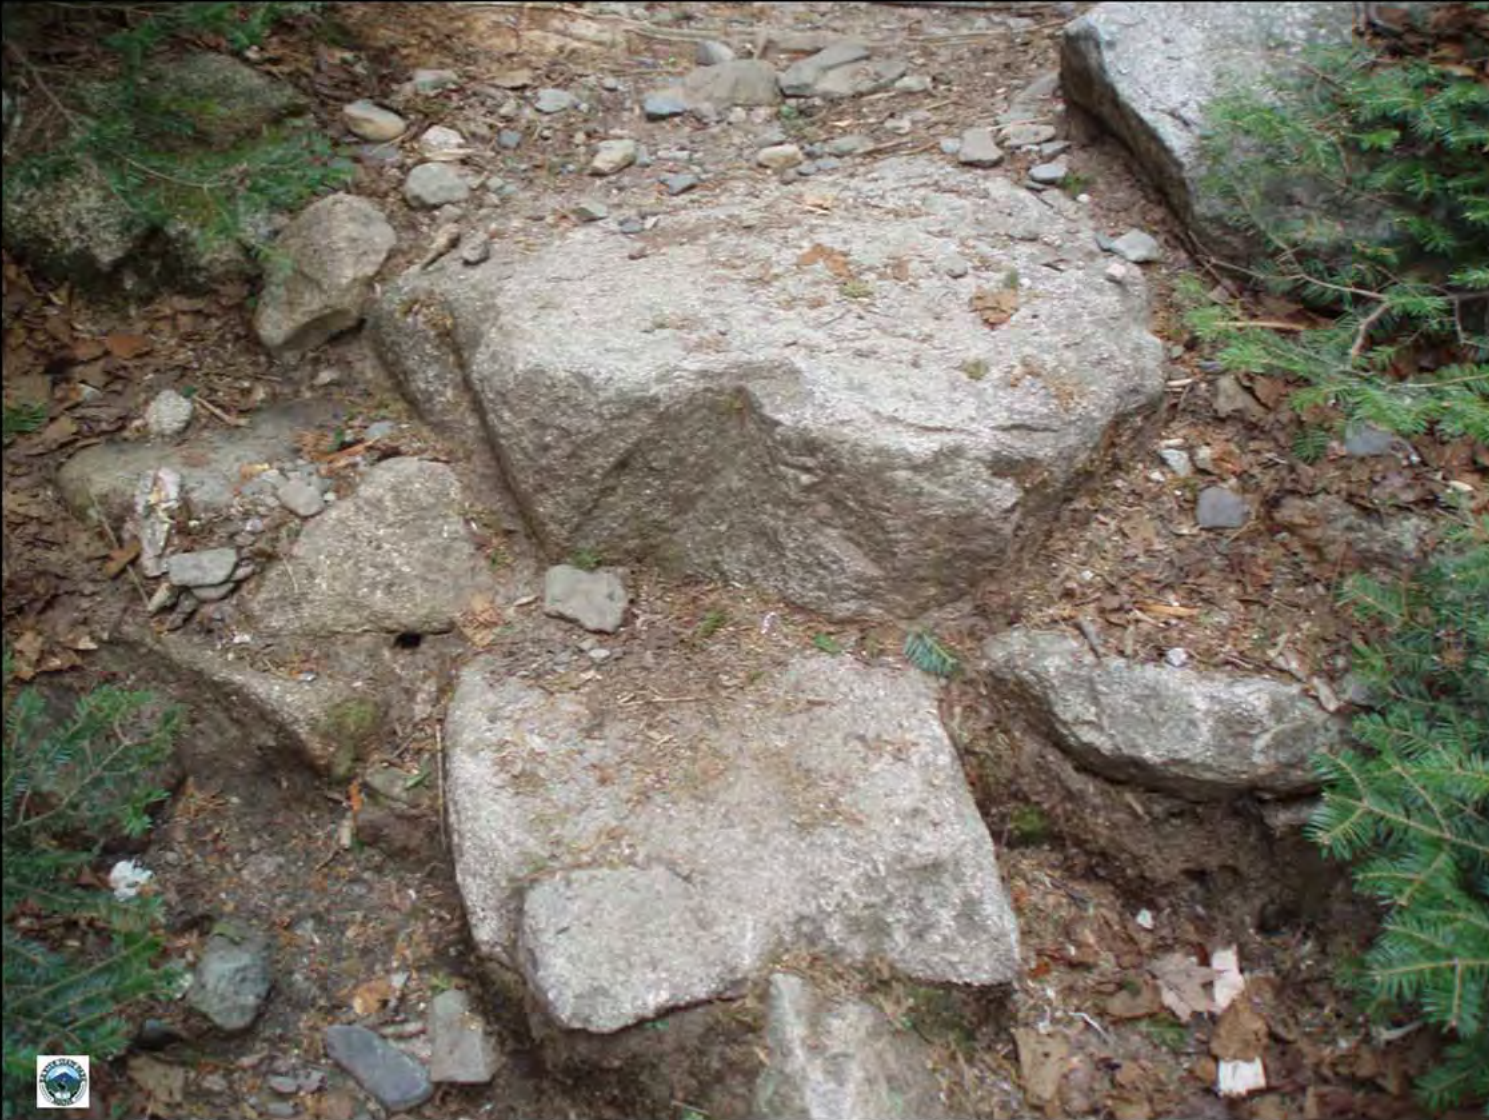
The data collection process works like this. The field technician locates a feature like these rock steps on the Chimney Pond Trail...

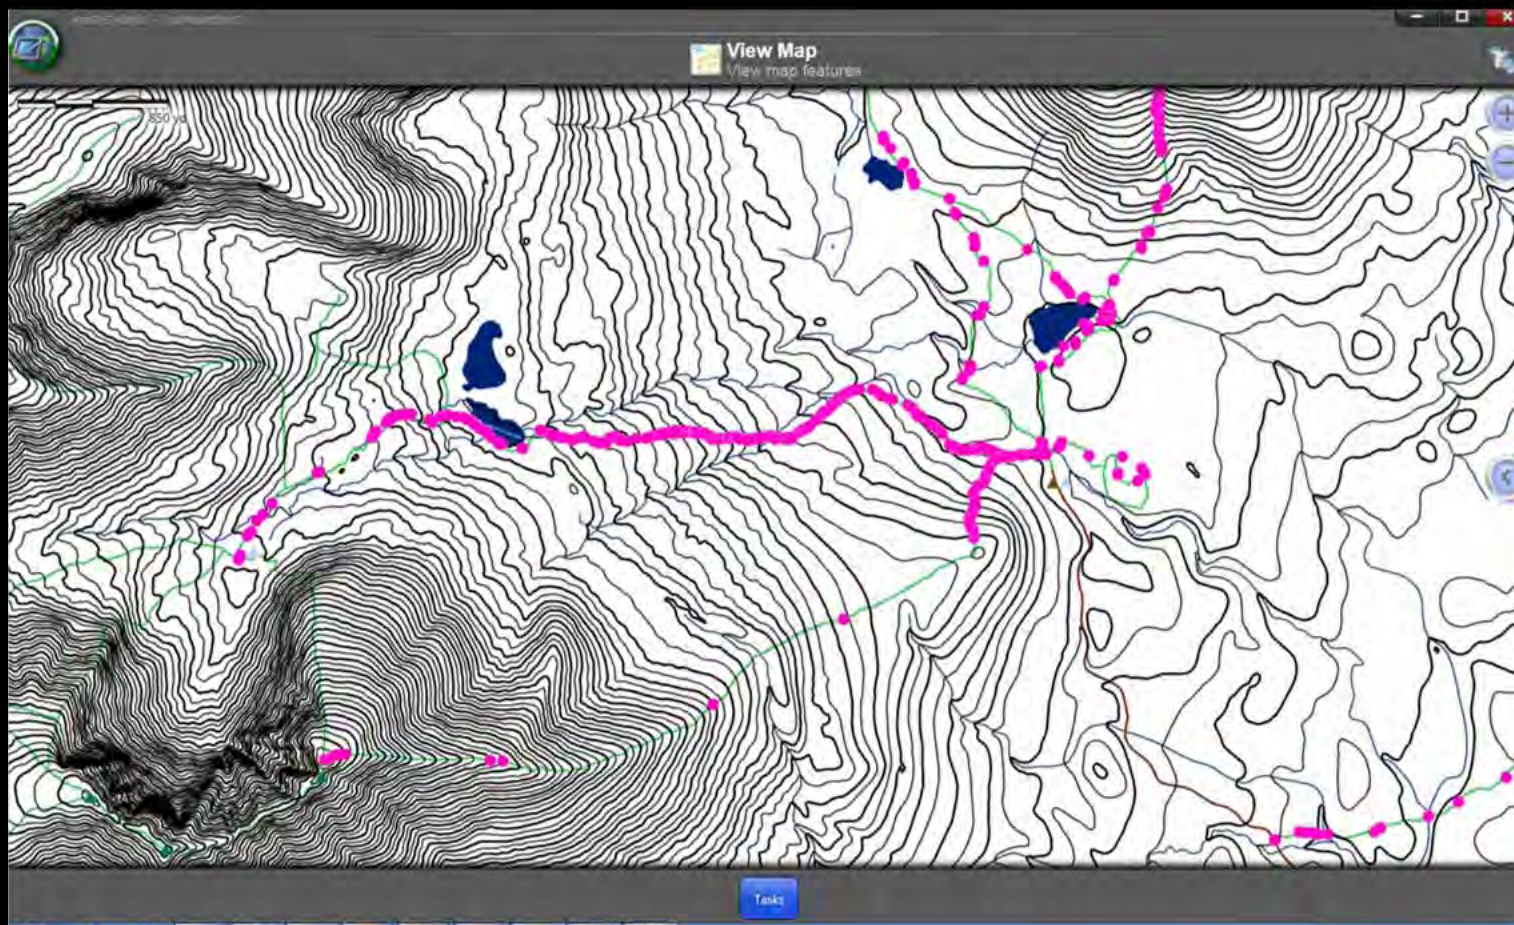
When they open up the software on these field computers it looks like this, showing topography, trails, and the pink dots are features that have already been collected.

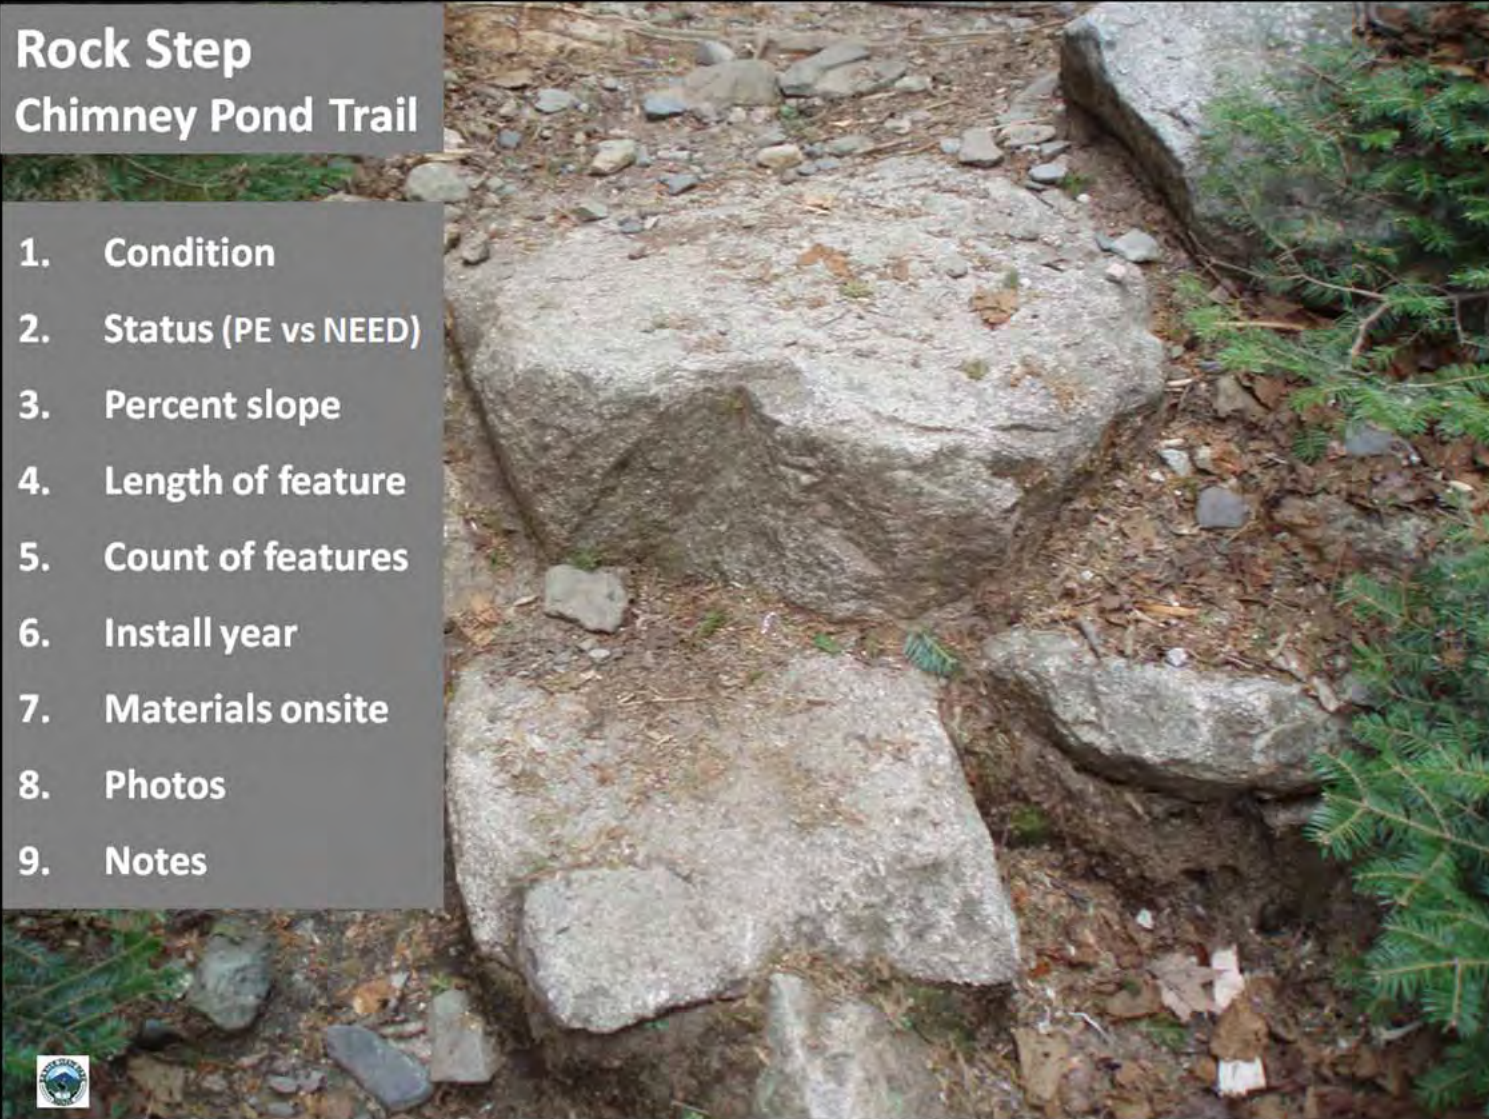
Rock Step Chimney Pond Trail

After that they work through a list of other attributes including the 1-5 condition class rating, whether the feature is pre-existing or needed, what the percent slope is at the location, the length of the feature if applicable, how many features are present (in this case 2 steps), the installation year if known, whether materials to repair or replace are on site, and then they took photos of the features like this image.

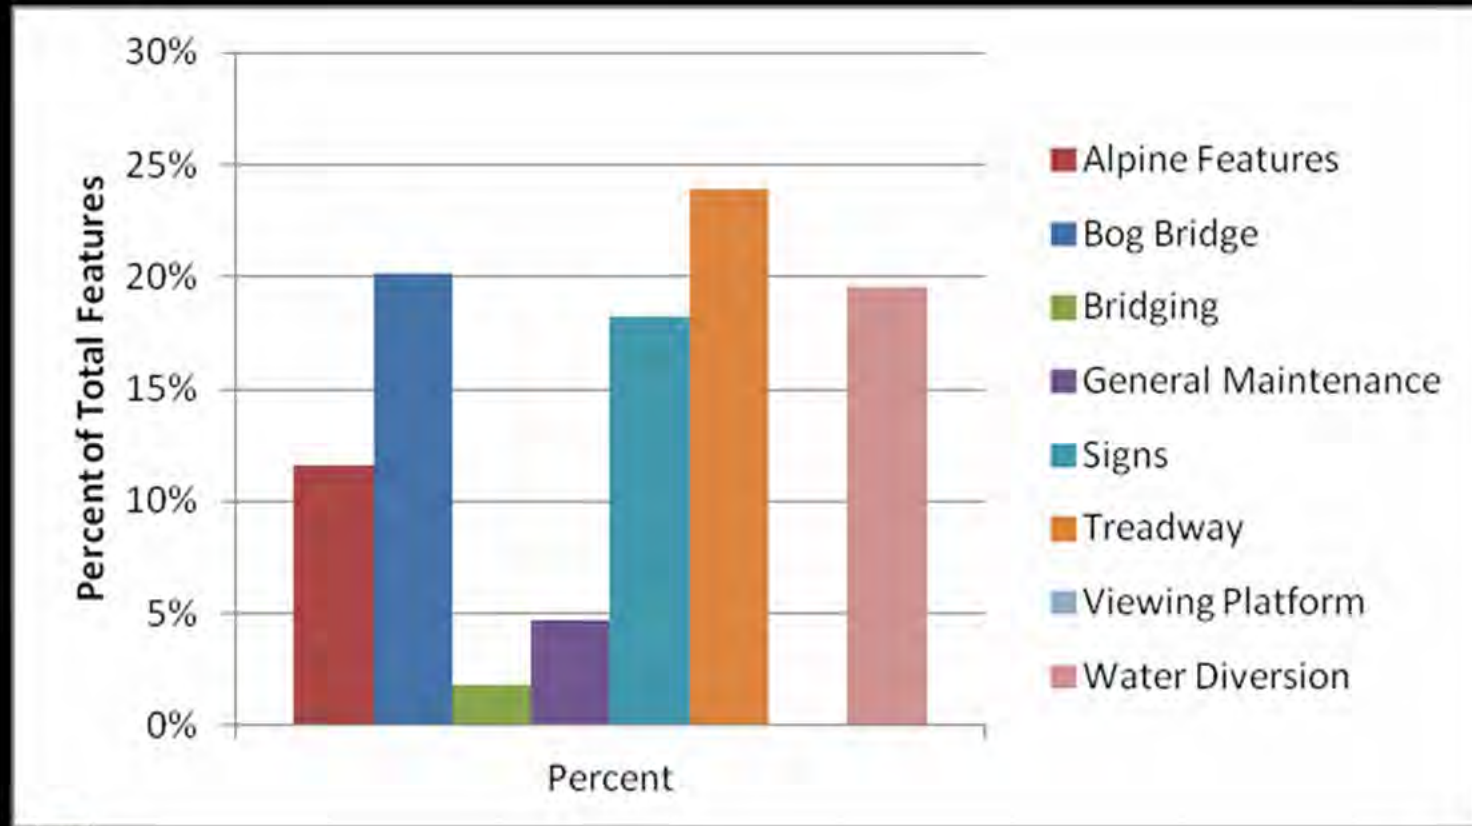
Percent of Features by Type

Lets begin with some basic summary statistic about the inventory data. This graph shows the percent of features broken down into some general categories like water diversion and treadway. You can see that the features are pretty well distributed between the major categories.

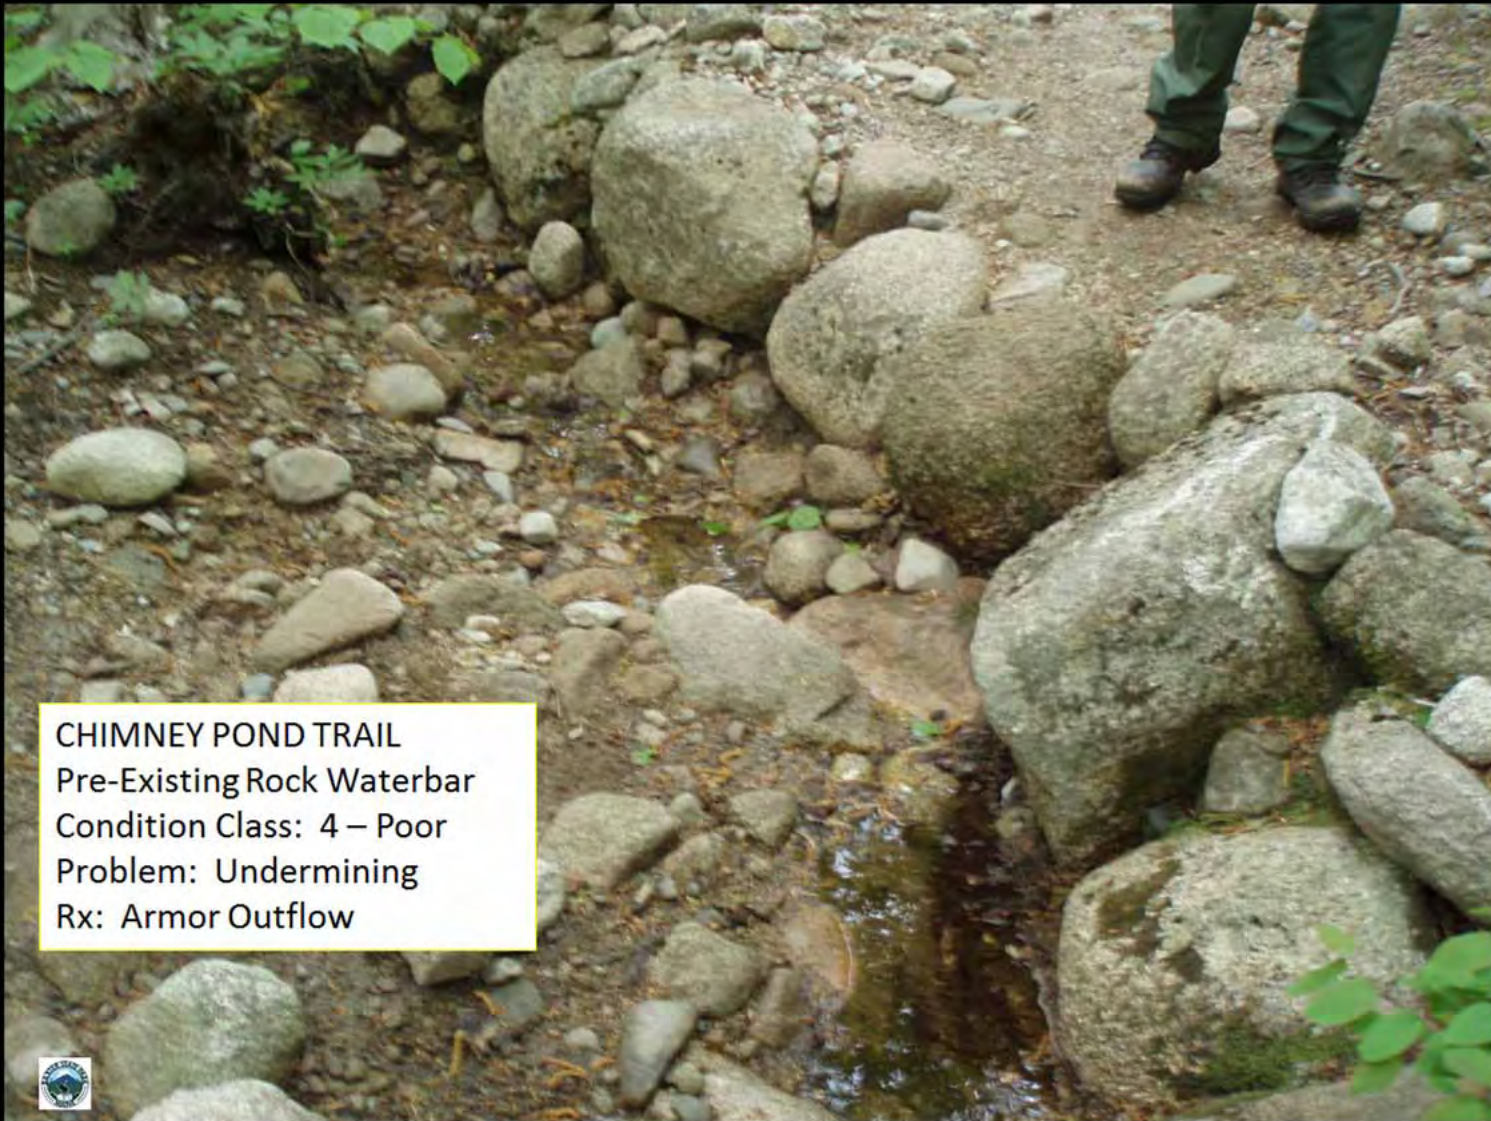
For example this rock water bar on the Chimney Pond trail, that is in poor condition. Paul can develop prescriptions for how to fix issues with this feature and then relay those to his staff in the field.
